NRL/MR/6136--00-8491

***USS Virginia* Ballast Tank Connector Qualification Study**

USS VIRGINIA BALLAST TANK CONNECTOR QUALIFICATION STUDY

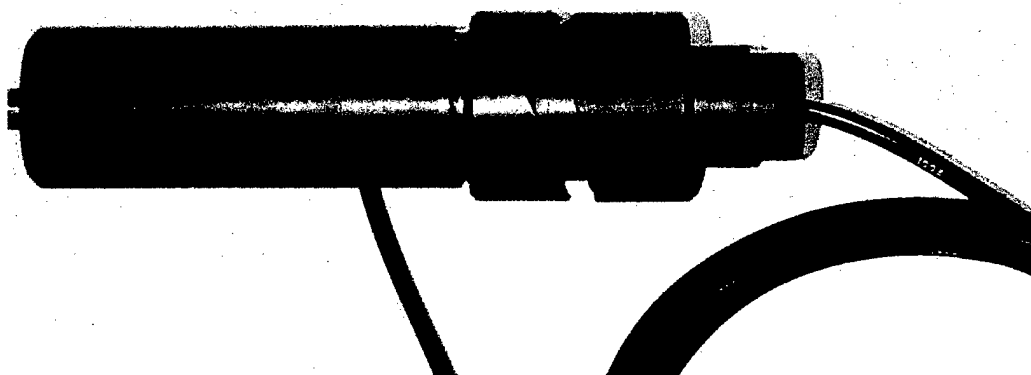
Figure 3. Photograph of Connector Failure during shipping

Concept C consisted of a solid PVC housing, as seen in Figure 1, while Concept D used a polyurethane mold at the cable connection, as shown in Figure 2. During unpacking of the connector assemblies, it was discovered that one of the Concept C assemblies was damaged in shipment. The threaded outer housing was cracked and indicated that the cap was probably over tightened during the assembly processes. Evidently a stress riser was created at a weak area of the cap, noted at the point in (Figure 3). The broken connector was returned to the manufacturer and a replacement assembly was received on May 16, 1999.

2. Because of the mechanical failure, which occurred during shipping, it is recommended that the machine specification for the "Concept C" connector be reviewed to insure that the connector cap cannot be over-tightened and that sufficient thread length is available to insure correct tightening and sealing without stressing the PVC cap during assembly.
